Bulletin No :  
CM-23-047-02-KEEN  
Date : Feb. 09, 2024  
Ref.PB No :

**ENGINE STOP SOLENOID FAILURE V2.1**

**MODEL : K008-5, U10-5, U15-3, U17-3a, KX015-4, KX016-4, KX018-4, AND KX019-4**

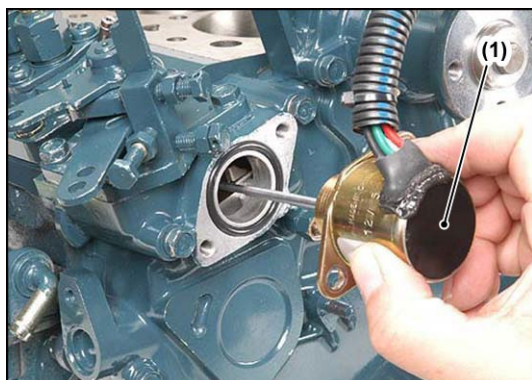
## 1. Removing the engine stop solenoid

(1) Engine stop solenoid

1. Remove the engine stop solenoid (1) according to the engine WSM.

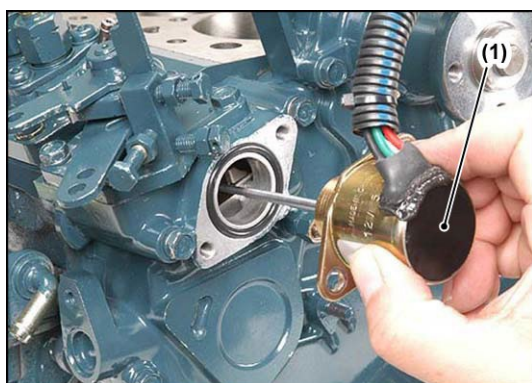
## 2. Installing the new engine stop solenoid

- 1 ENGINE, SERVICING
  - > 4.CHECKING, DISASSEMBLING AND SERVICING
  - > [2] DISASSEMBLING AND ASSEMBLING
  - > (4) Gear Case and Timing Gears, Injection Pump, Fuel Feed Pump and Speed Control Plate
  - > Point 7
- The new engine stop solenoid (1J022-60020) has the white marking (2).

(1) Engine stop solenoid: 1J022-60020

(2) White marking

1. Install the new engine stop solenoid (1) according to the engine WSM.
