### SERVICE – BULLETIN

Reference-N°: KTSE - SB - 2209

#### Self-reliant turned on Parking Lights

Model	Serial N°
R070	→ 10693
R090	→ 10363

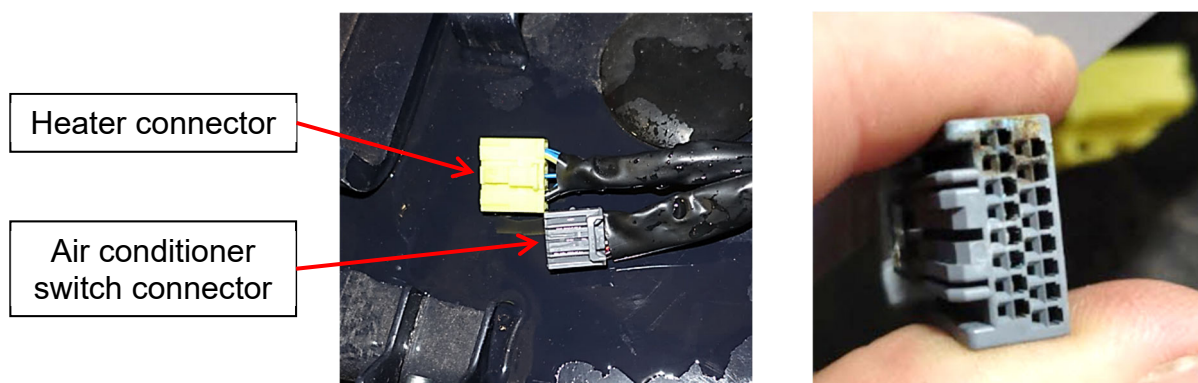
Cases of parking lights turned on with the ignition switched off have been reported, this could lead to a drained battery. Investigation revealed that insufficient fixation of the wire harness might allow its unused air conditioner switch connector to lie in residual rain or washing water. This could result in a short circuit, enabling the parking lights to turn on self-reliant. As series countermeasure the routing of the connector was improved by adding a cable tie. For the machines in the field, we herewith inform you the measure to be taken in such failure cases.

In case of symptoms as explained above, one possible cause among others can be the insufficient fixation of the wire harness. First confirm if the connector under the right-hand cover has or had contact with water. In such a case, the wire harness has to be rerouted to prevent the connector from direct contact to water following the below instructions.
