KUBOTA Technical Support centre Europe

SERVICE – BULLETIN

Reference-N°: KTSE - SB - 2207

Water Ingress into the Cabin

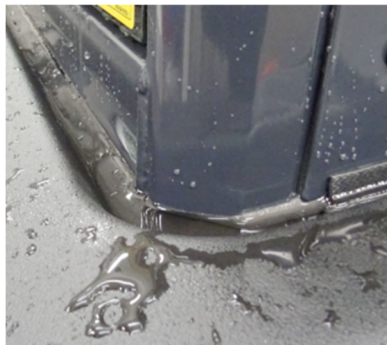
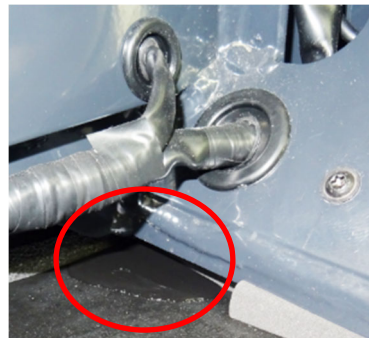
Cases of water intrusion at the rear part of the cabin have been reported. Investigations revealed that the water entered through the gaps between the cabin seals. As a series countermeasure, the separated cabin seals have been replaced with a continuous seal. In case of water ingress on the rear side of the cabin follow the instruction below.

In case of water intrusion to the cabin as explained above, the cabin seals must be replaced according to the following procedure.
