KUBOTA Technical Support centre Europe

SERVICE-BULLETIN

Reference-N°: KTSE - SB - 1804

Reinforcement of Cabin Door Hinges

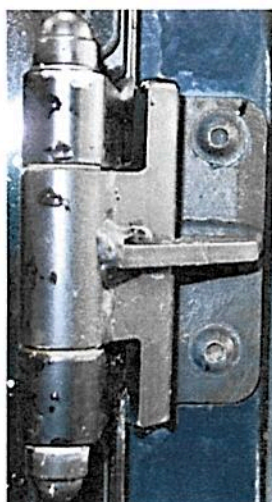
Original

Cases of cracks on the cabin frame around the door hinge fixation have been reported. Investigation revealed that this was a result of material fatigue.

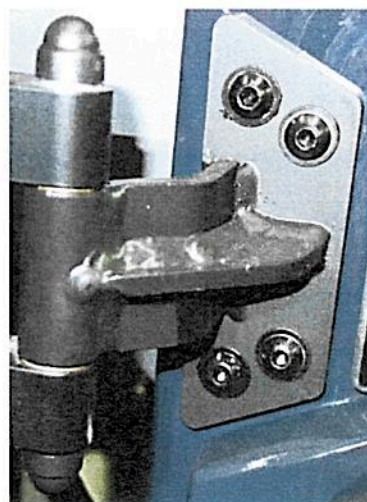
Series countermeasure

- the left-hand cabin post was reinforced,
- the hinge contact plates were enlarged and the fixation was improved by two additional bolts,
- a door stopper was added on the rear left-hand post.
