SERVICE-BULLETIN

Reference-N°: KTSE - SB - 1503

Measures against Heat and Noise in Cabin on U27-4

Model	Serial N°
U27-4	→ 57197

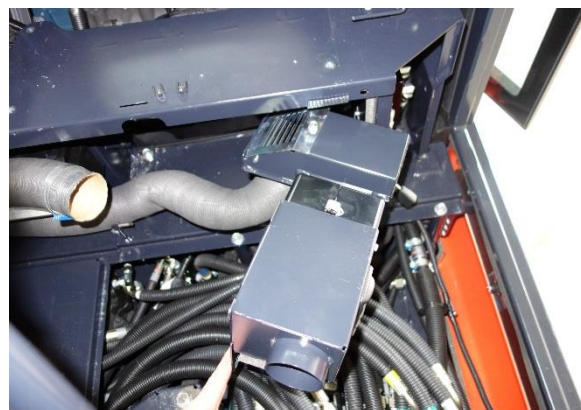
Step 15:

Do not pull out the heater too far, as the coolant hoses remain connected to the heater and could get ripped-off.

Move the heater to the side like shown in the picture.
