SERVICE – BULLETIN

Reference-N°: KTSE - SB - 1504

Preventive Measures against hydraulic Gear Pump Shaft breakage

Model	Serial N°
R065	See list at the end of the bulletin

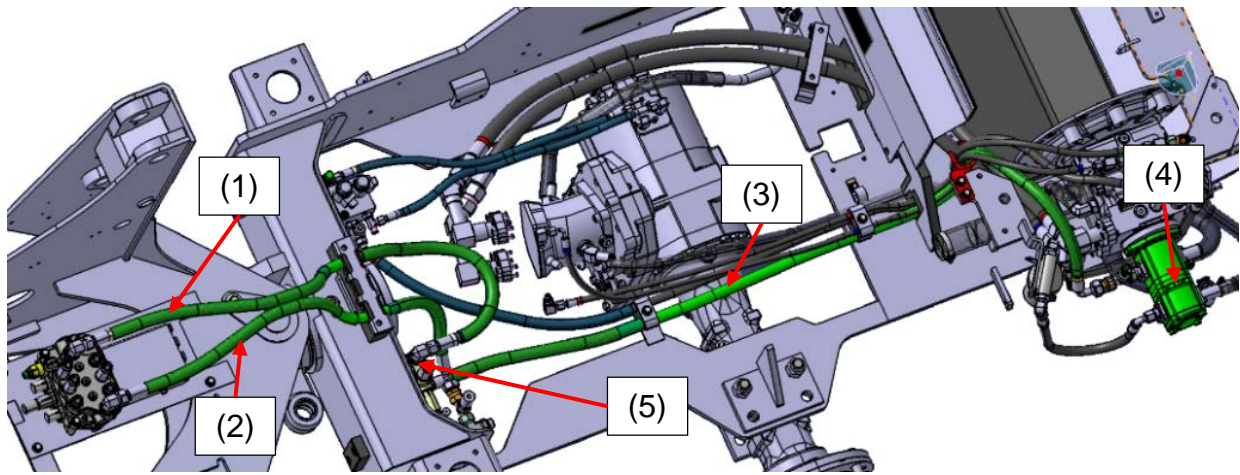
It has been noticed that the gear pump drive shaft provides insufficient torque resistance against pressure peaks. In the worst case the drive shaft can break.

As series countermeasure, a new gear pump with improved drive shaft torque resistance has been adopted. Additionally the back pressure in the gear pump's hydraulic circuit has been lowered by increasing the inner diameter of the main hydraulic hoses. Finally, the priority valve's machining process was stabilized in order to avoid the possibility of surge pressure generation.

- (1) Hydraulic hose priority valve -> control valve
- (2) Hydraulic hose control valve -> hydraulic tank
- (3) Hydraulic hose gear pump -> priority valve
- (4) Gear pump
- (5) Priority valve

We herewith inform you the preventive measures you need to take with highest priority on machines prior to above improvements.

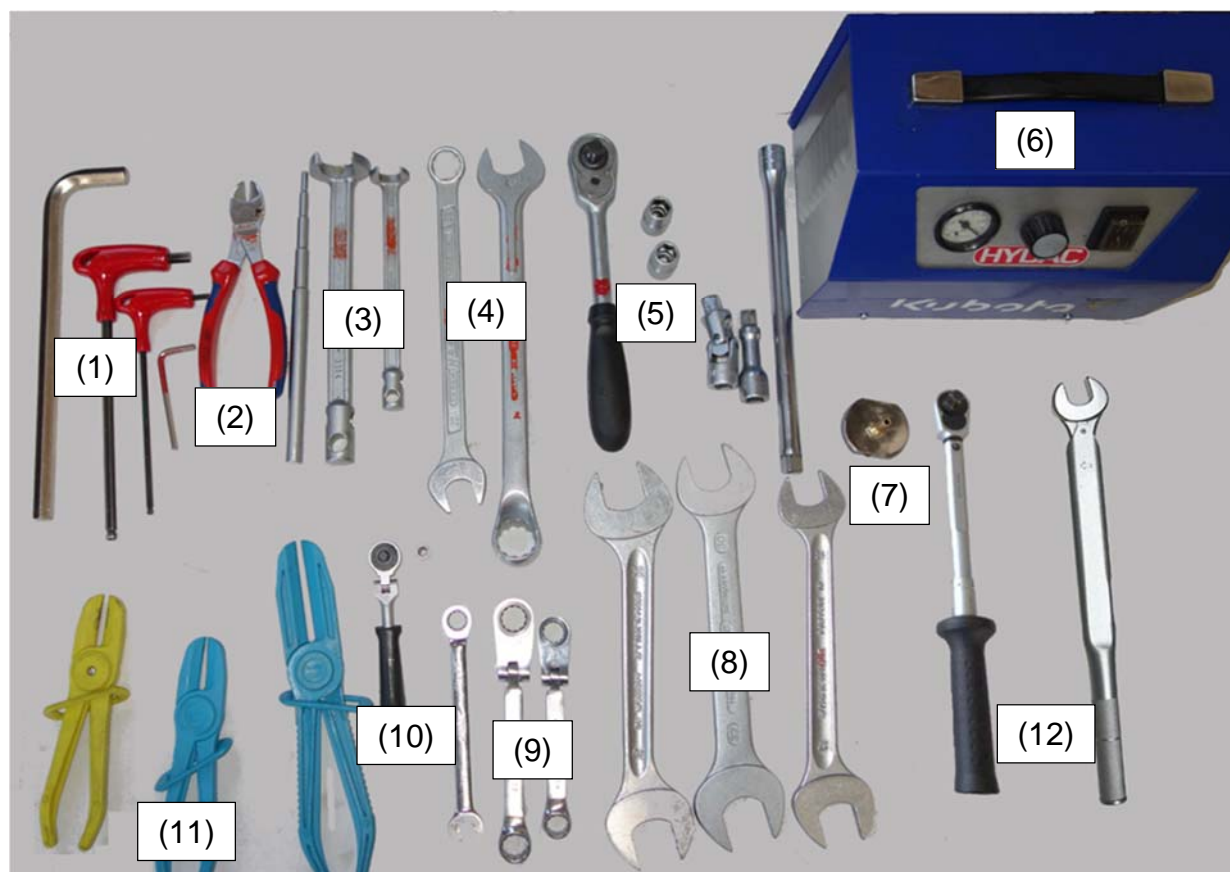
Tools:

(1) Allen wrenches 14mm, 8mm, 5mm (2x)	(2) Side cutter
(3) Claw type wrenches 27mm, 19mm, mandrel	(4) Combination wrench 27mm, 22mm
(5) Ratchet ½', socket 14mm (2x) Extensions 250mm and 75mm Joint	(6) Vacuum pump
(7) Connector M33x2 for vacuum pump	(8) Wrenches 27/24mm, 32/30mm (2x)
(9) Ratchet ring spanners 17mm, 14mm, 12mm	(10) Ratchet 3/8', socket 7mm
(11) Plastic hose clamp pliers for hose diameter 30mm (2x), 60mm (1x)	(12) Torque wrenches 5N·m -50N·m, 20N·m - 200N·m

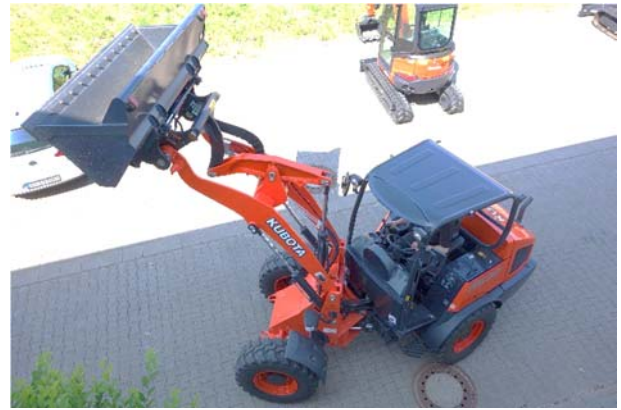
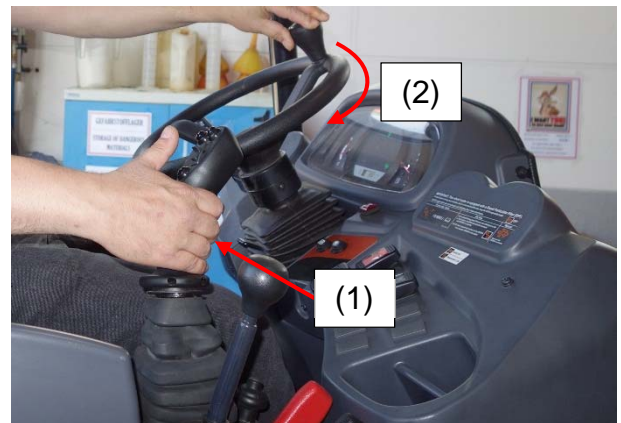
Step 1:

Start the engine and, with parking brake engaged, increase engine rpm to max rpm. Lift the front arm up to end stroke (1) and steer the machine completely to the right (2). Keep the pilot lever activated in arm lift position and simultaneously keep force to right end stroke on the steering wheel for about five seconds. Then, with the pilot lever still activated, just get off your hands from the steering wheel (do not operate it in opposite direction).

Case A- Normally, no damage would happen and all functions would be OK. This indicates that the priority valve is OK and does not require replacement. In this case please proceed to all steps (2 to 69) of Case A.

Case B- In very rare cases, some noise will occur and F/A and steering would not function anymore. This indicates that the gear pump shaft is broken because of a bad machining inside the priority valve. In those cases, please:

- immediately proceed to all further steps (2 to 69) of case A. The machine will be usable even with the bad priority valve. There will be no additional machine downtime.
- upon order and receipt of additional parts required for case B, revisit the machine and proceed to all steps (1 to 38) of case B.

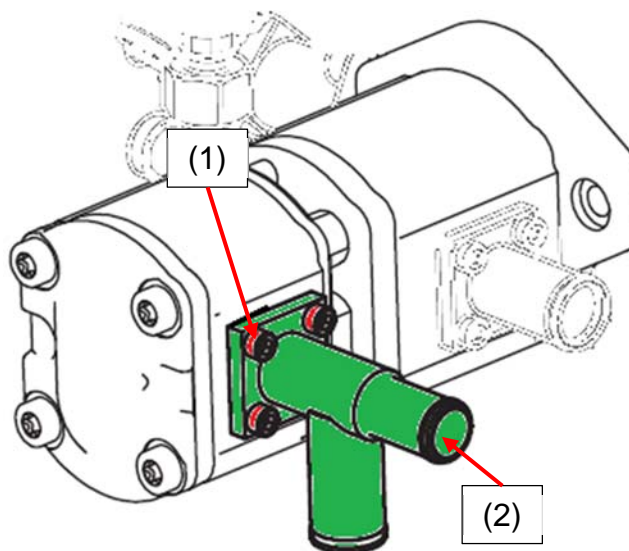
Step 28:

Remove the four bolts (1) and the flange (2) of the gear pump (R5511-7601-2).

Install the flange (2) with the four bolts (1) onto the new gear pump (3) (R5511-7601-2).

Tightening torque: 7,8N·m-9,3N·m.

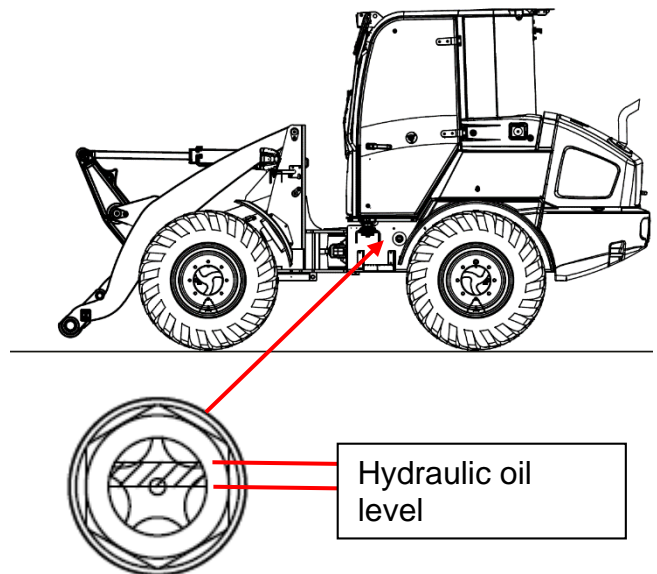
**Step 63:**

- Arm in the lowest position
- Bucket (quick coupler) in crowd position
- Front frame in straight position

Hydraulic oil level should be filled up $\frac{1}{2}$ to $\frac{3}{4}$ of the gauge glass.

Stop the engine and check the oil level in the hydraulic tank, but do not close the hydraulic tank after refilling the oil.

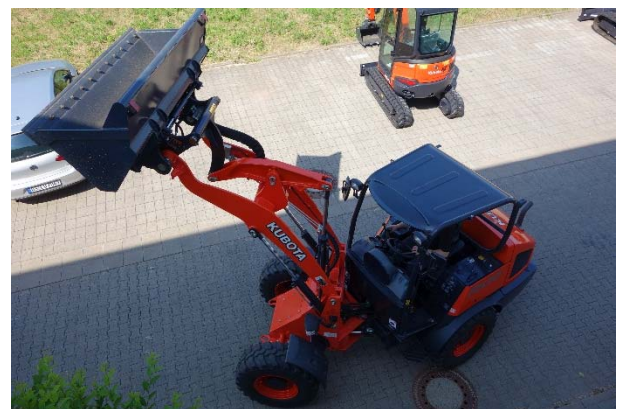
**Step 64:**

Installing the tank cover plug in this position is important to avoid vacuum in the hydraulic tank.

Start the engine carefully with idle rpm. Lift up the lift arm, close the bucket and turn the steering to the right. Stop the engine and close the hydraulic tank with the plug.

Tightening torque: 40N·m – 45N·m

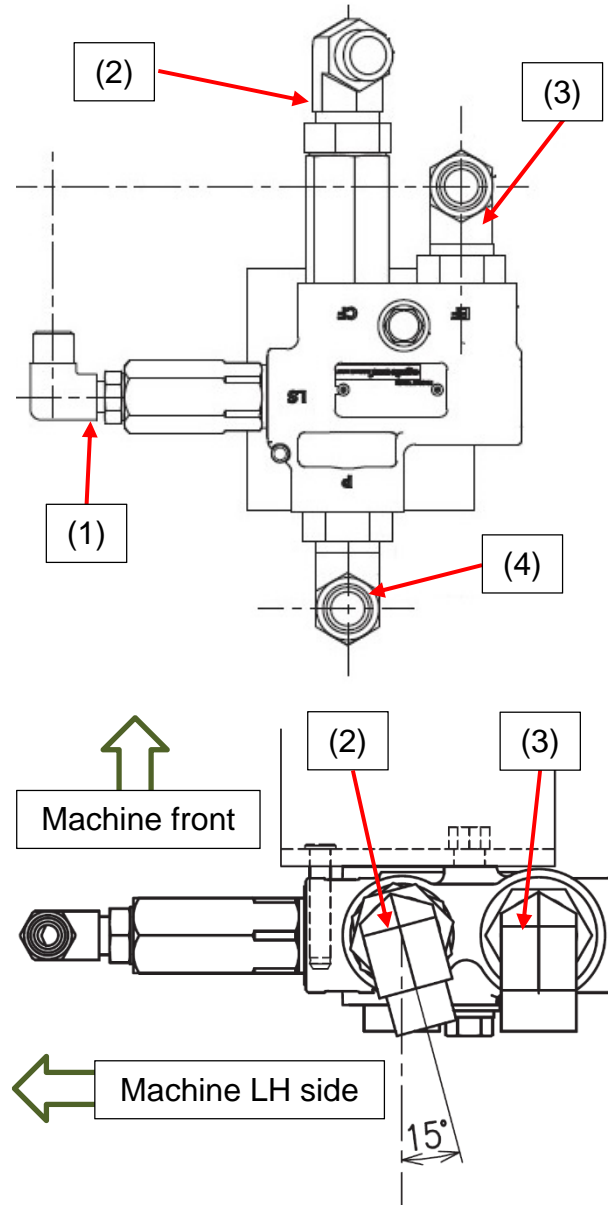
Step 6:

Fix the priority valve in a vice and remove the adapters in sequence (1), (2), (3) and (4).

Replace the priority valve by the new one (R5611-6136-0) and reinstall the original adapters again. The adapter (2) should be mounted with a 15° angle.

Position 1: 25N·m-30N·m

Position 2: 70N·m-75N·m

Position 3, 4: 115N·m-125N·m.

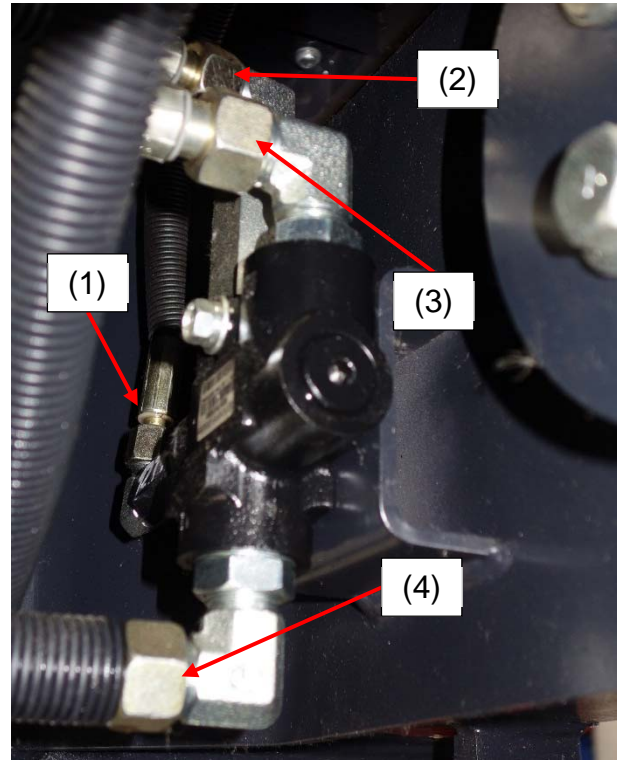
Step 9:

- (1) "LS": from steering valve
- (2) "CF": to steering valve
- (3) "EF": to control valve
- (4) "P": from gear pump

Remove the plugs from the hoses and connect them onto the adapters.

Position 1: 15N·m-20N·m

Position 2: 40N·m-45N·m.

Position 3, 4: 50N·m-55N·m.
