Zweibrücken  
09.08.2022

### SERVICE – BULLETIN

Reference-N°: KTSE - SB - 2111

#### Broken Control Valve return Springs

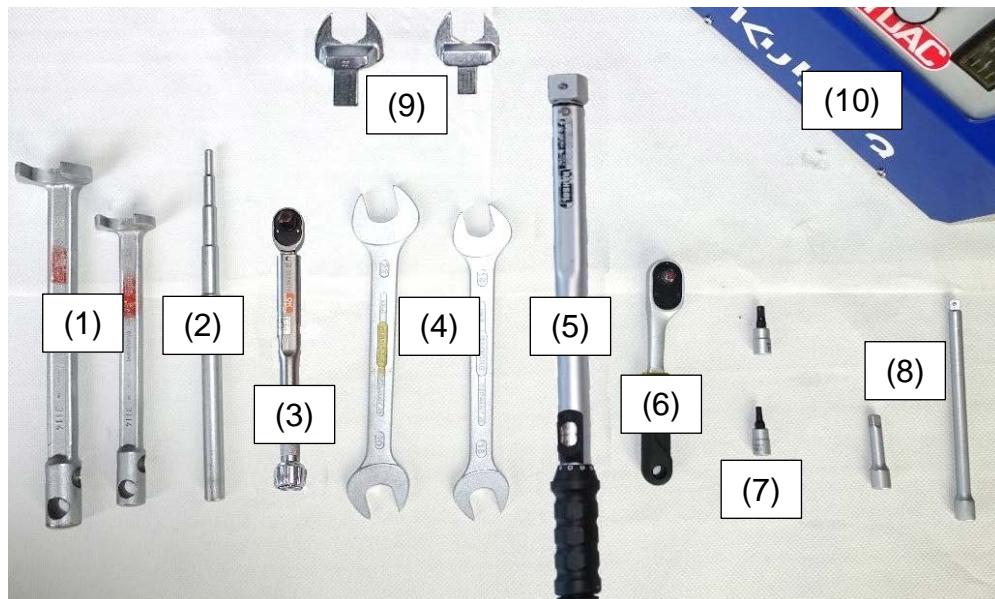
#### **Tools and consumables:**

- |   |                                     |

| (1) Crowfoot wrenches, 22, 27 mm | (6) Ratchet 1/4" |
| (2) Handle | (7) Hex sockets, 4, 5 mm |
| (3) Torque wrench, 1/4", 0,5 N·m - 20 N·m | (8) Extension bars 1/4", 50, 150 mm |
| (4) Spanners, 19, 22 mm | (9) Sockets, 19, 22 mm |
| (5) Torque wrench, 20 N·m - 200 N·m | (10) Vacuum pump with G3/4 adapter |

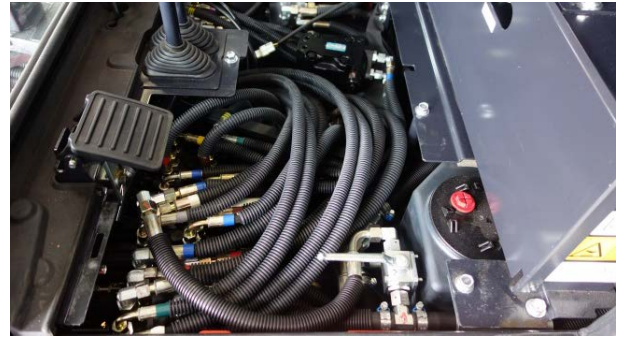
**Step 4:**

Depending on the model and the section, there are different hoses that need to be removed.

Take notes of the hose connection of the affected section and disconnect the related hydraulic hoses to gain access to the affected section.

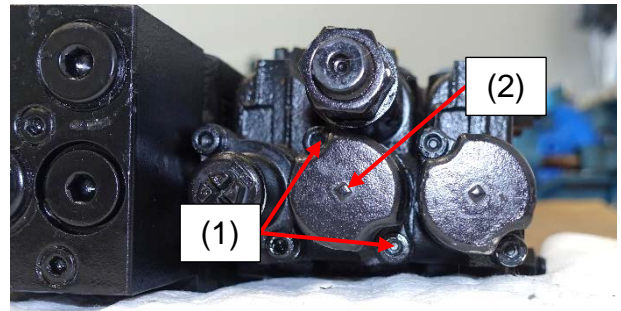
**Step 5:**

The bolts (1) and the cap (2) can be scrapped.

Remove the two bolts (1) and the cap (2) of the concerned section.

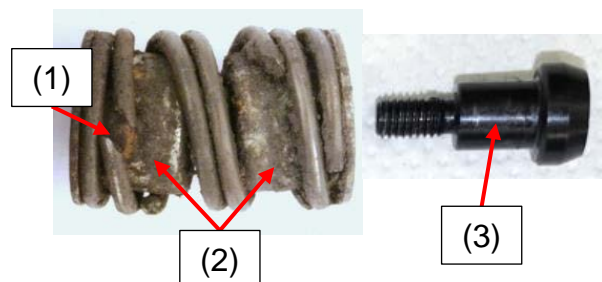
**Step 7:**

Take a picture, clearly showing the broken spring (1).

The spring (1), the spring seats (2), and the bolt (3) can be scrapped.

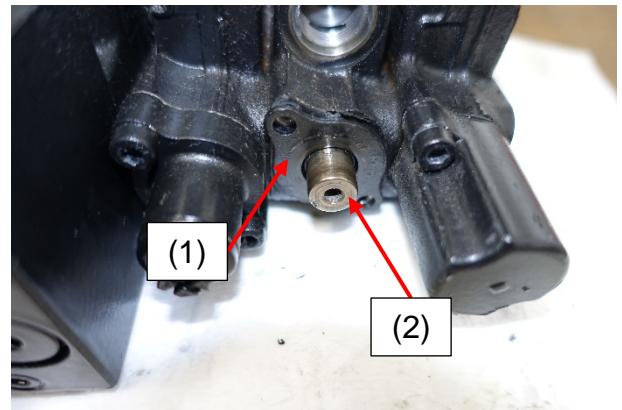
**Step 8:**

The cover plate (1) can be scrapped.

Remove the cover plate (1) and clean the protruding end of the spool (2).

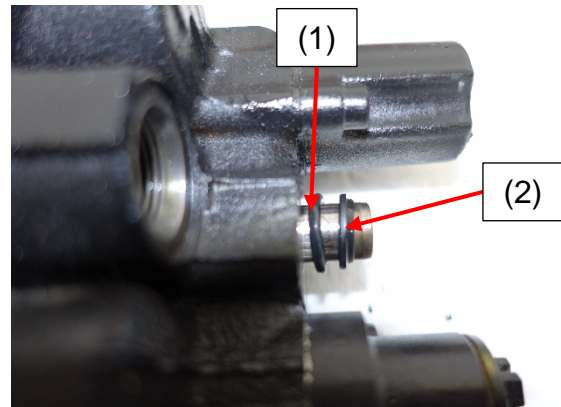
**Step 9:**

The O-ring (1) and the seal (2) can be scrapped.

Remove the O-ring (1) and the seal (2).
