KUBOTA Technical Support centre Europe

SERVICE – BULLETIN

Reference-N°: KTSE - SB - 2207

Water Ingress into the Cabin

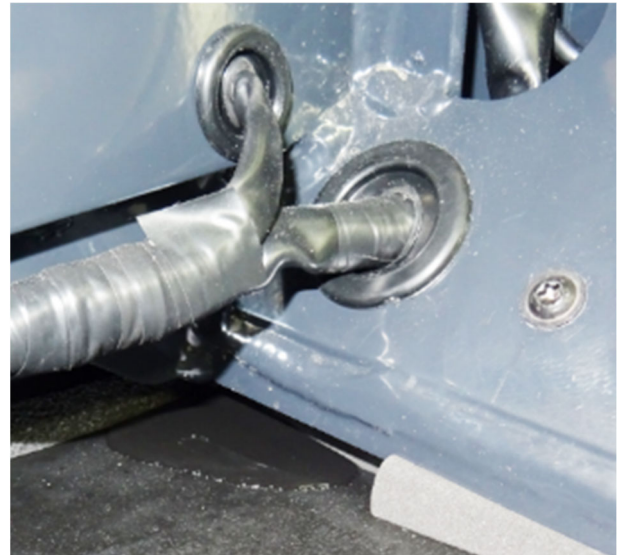
Step 1:

Take a clear picture, showing the water ingress.

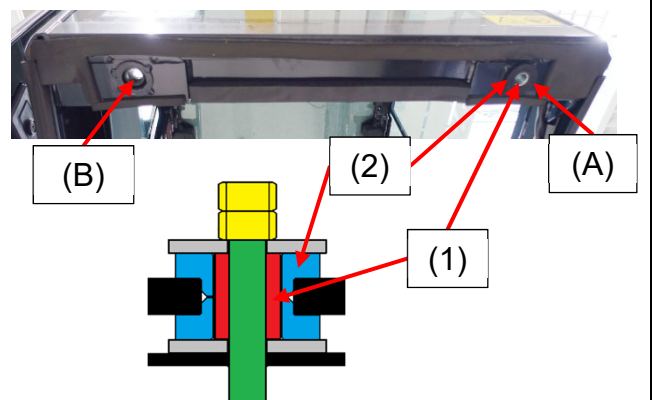
**Step 17:**

(A) Correct

(B) Not correct

Assemble the cabin onto the frame.

Make sure that the sleeves (1) and the rubber buffers (2) are installed correctly.
